## Case Study

# Sports Field Remediation

SETTLEMENT MITIGATION

UN-ENGINEERED &  
UN-CONTROLLED TIP SITES

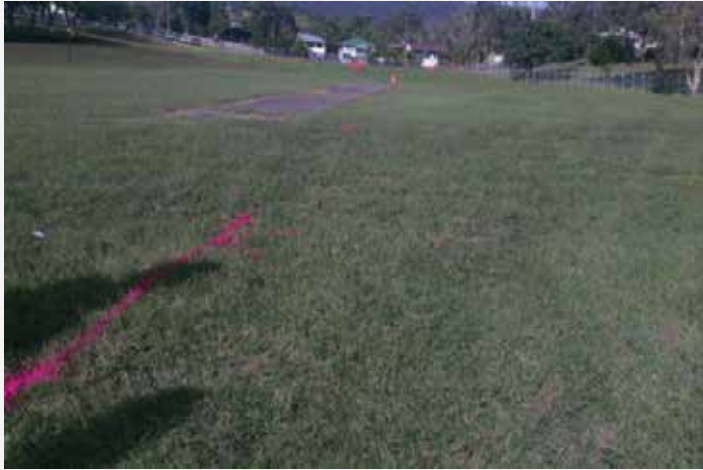
## Pre Impact Compaction

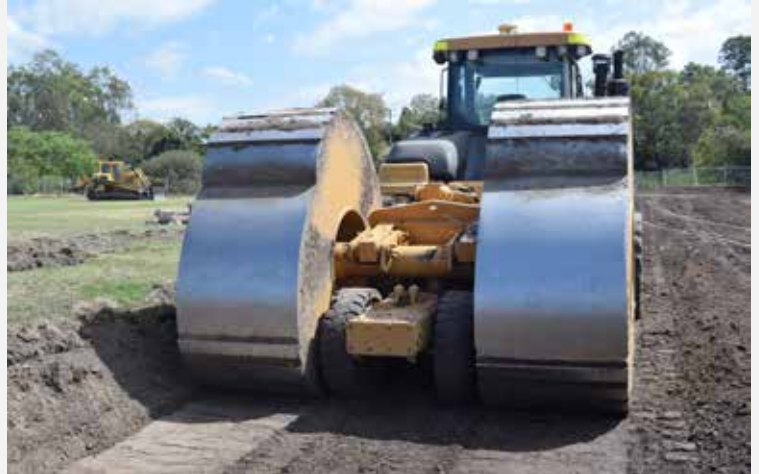
## Post Impact Compaction

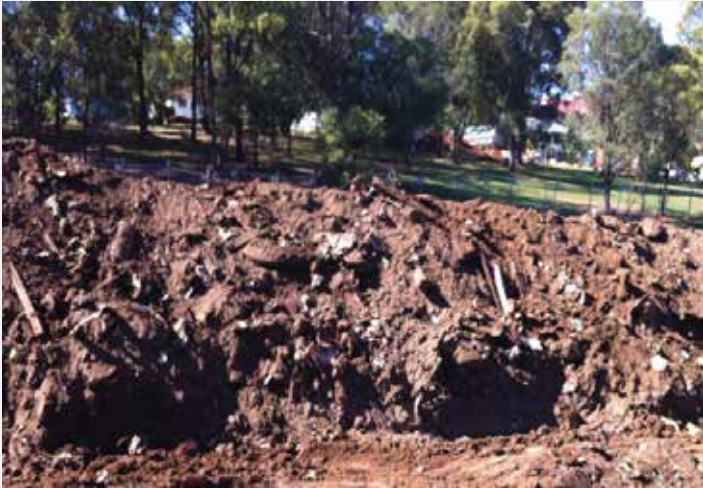
The sub-surface soil profile generally consists of general household waste with a clayey capping layer and top soil.

## Sub Surface Material

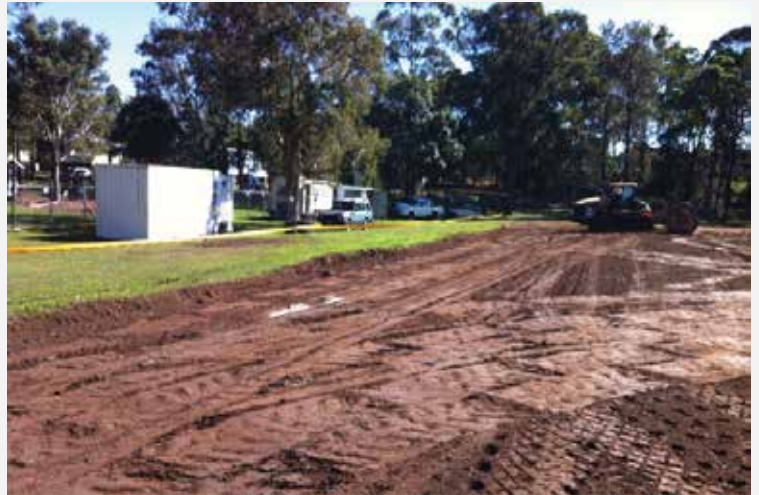
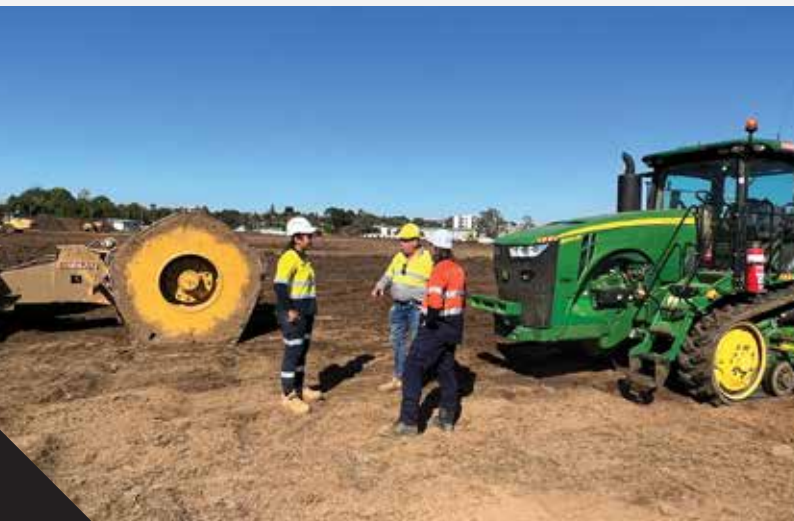
## Large Average Settlements Post IC
