Case Analysis

Marlin Coast Waste Water Treatment Plant Cairns, QLD

DEEP IMPACT COMPACTION

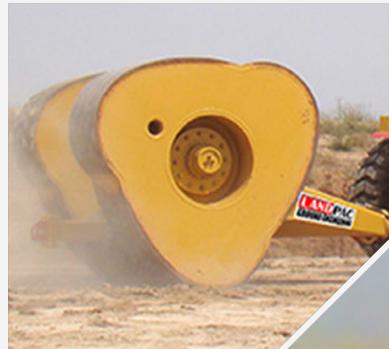
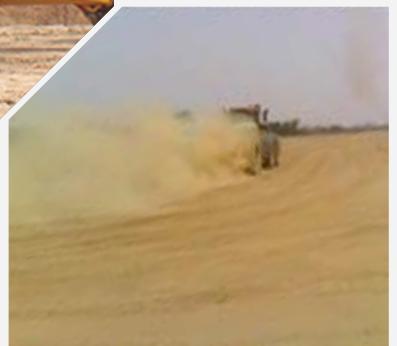
Impact Compaction using one of Landpac's 135kJ machines was used to compact the in-situ fill. Deep Impact Compaction was used to densify the sub-grade down to 5m (to achieve $\geq 5\text{ MPa}$ down to 5m) as it was not economically viable to remove and replace PASS and possible ASS materials with the water table up to 0.8m in places below the impacted working surface.

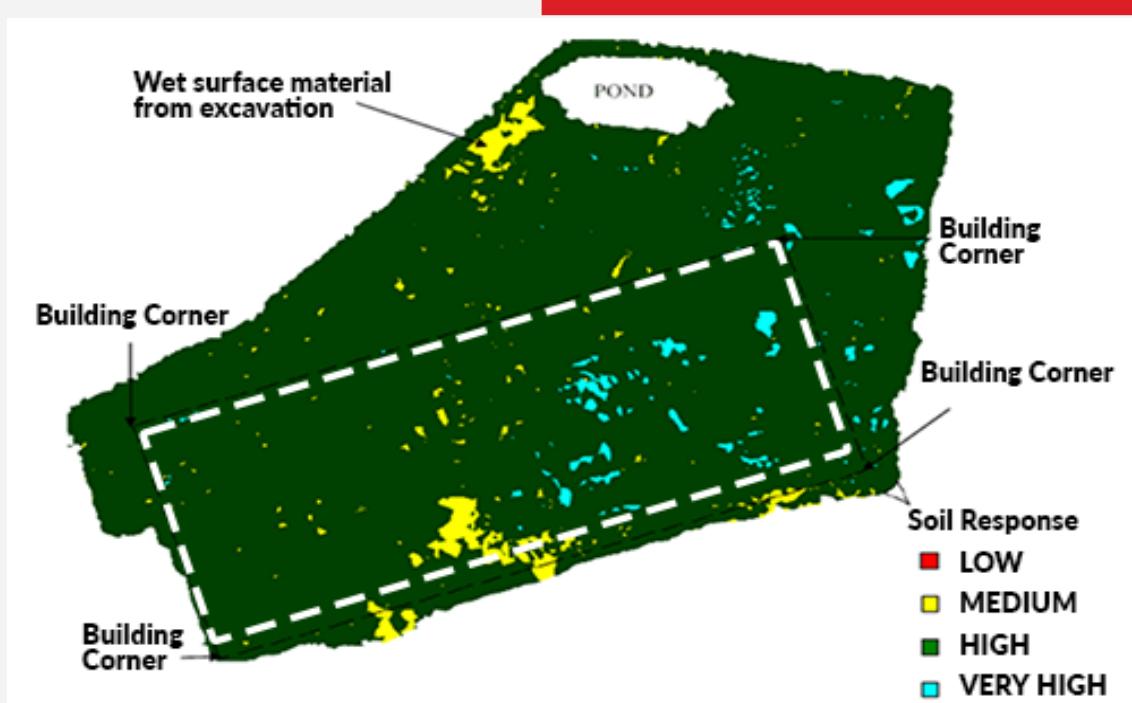
Soil Response

The compacted areas are indicated on the soil response plot (CIR) in the image shown. Low or medium response locations on the CIR plot identified the material as silty clay with high moisture content which proved un-compactable until replaced.

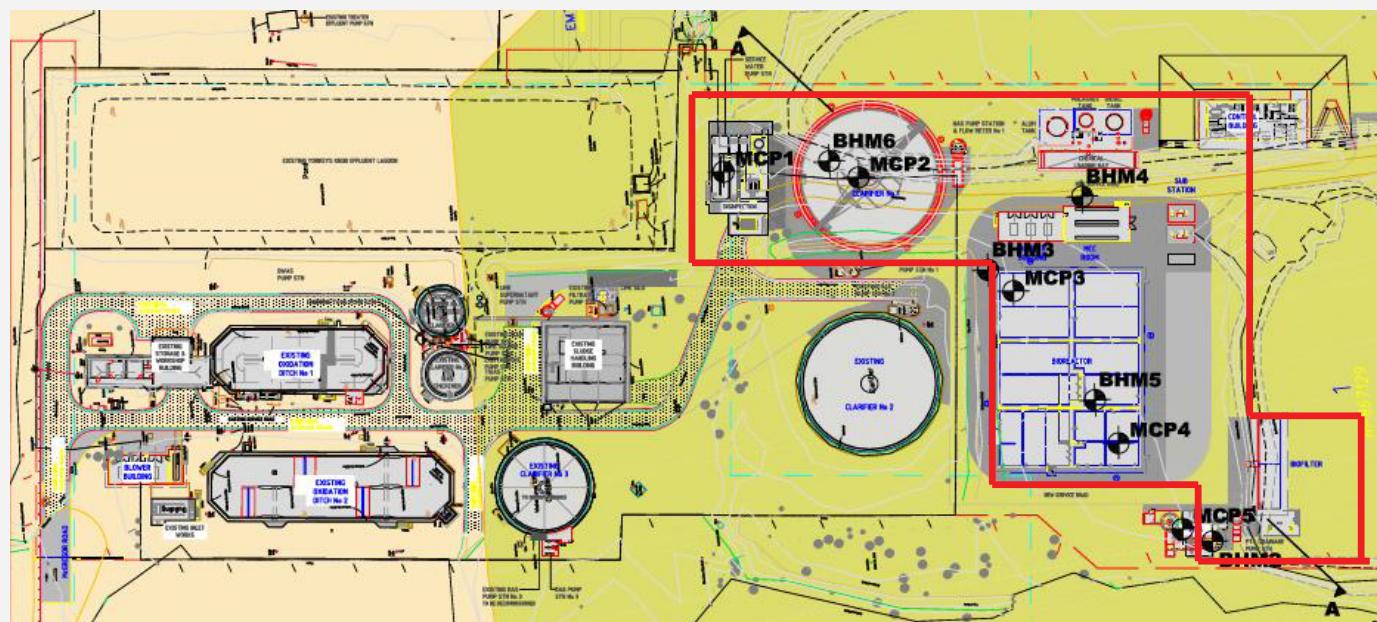
Compaction Zone

Landpac used their integrated GPS technology to identify the weaker pockets present with in the sub-grade. Weaker areas were replaced with good compactable material and then using the 135kJ machine the replaced sub-grade was subject to impact compaction.
