Case Analysis

Reliance Rail Maintenance Facility

Auburn NSW

DEEP IMPACT COMPACTION

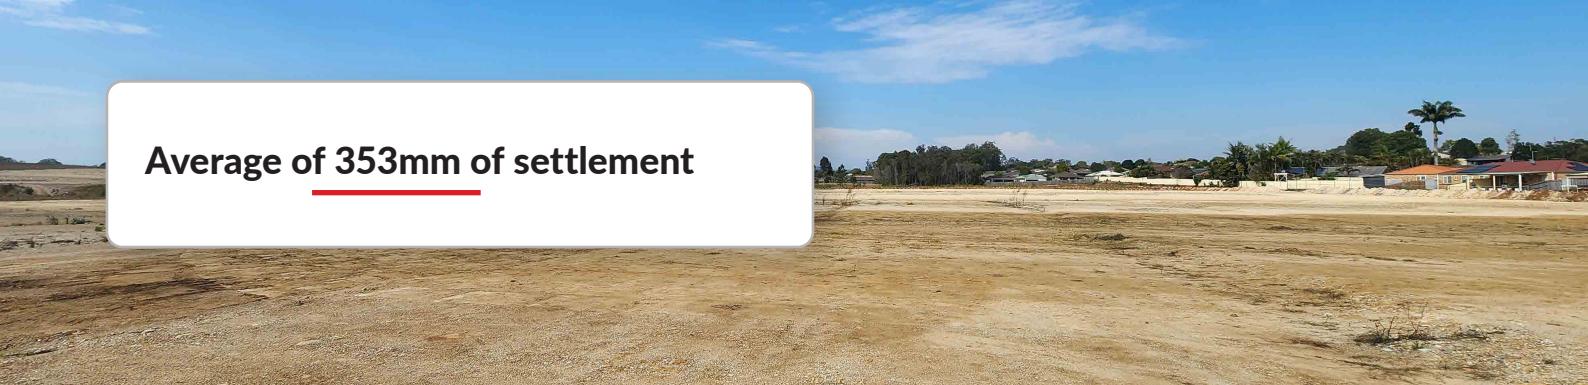
Average of 353mm of settlement

Intelligent Compaction Measurement was carried out to identify soft spots and settlement monitoring carried out to assess total differentials achieved as well as total average settlements across the site. An average of 353mm of settlement was recorded across the site with maximum and minimum settlements of 680mm and 160mm respectively. The ground response monitoring indicated a consistent stiffness across the site area after 70 surface coverage's. There appeared to be a very dense surface crust and the impact compactor took between 20-30 passes to punch through this dense crust hence the massive increase in average settlement from 20-30 passes.

The massive settlement achieved, and increase in stiffness values would suggest that there is close correlation between the ICM data signifying that there has been a huge increase in densities/stiffness over the area. A very dense surface crust was present, and the impact compactor required approximately 20-30 passes to penetrate it. Once breached, a marked increase in average settlement was observed.
