# GROUND IMPROVEMENT AND VALIDATION FOR STAGE 1 IMEX EARTHWORKS

Q J Yang<sup>1</sup>, A Succar<sup>2</sup>, J McIlquham<sup>3</sup> and K Chen<sup>4</sup>

This paper presents a case study of the use of an alternative ground improvement technique to treat contaminated uncontrolled fill other than traditional “remove and replace” for major earthworks for the proposed container Import and Export (IMEX) Terminal at Moorebank, Sydney. First, a brief discussion of the options considered for the ground improvement including removal and replacement and the Impact Roller Compaction (IRC) method will be presented. The local geological setting and the historical form of the existing Stage 1 IMEX Terminal site will be described, with the geotechnical model and associated design engineering parameters being surmised. The key points in the development of a technical specification are presented to take account of the performance requirements, including on-site IRC trial and validation testing. The primary validation measures adopted comprise plate load testing, cone penetration profiling (CPT), insitu density testing, dilatometer (DMT) testing and proof rolling after IRC treatment. Surcharging

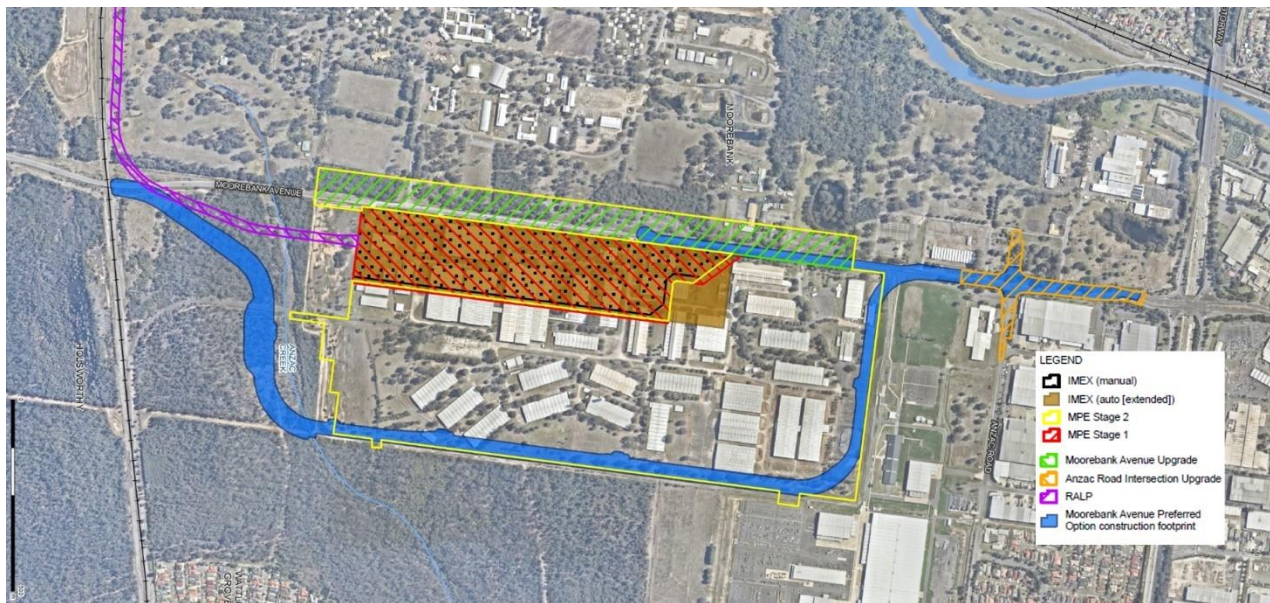
**Figure 1: Terminal Footprint (image © Google Maps)**

The site is located approximately 28 km to the south west of Sydney. The site was previously occupied by the Defence National Storage and Distribution Centre (DNSDC), and comprised multistorey buildings, large storage warehouses, roads, pavement areas, outdoor sitting areas, grassed areas and a refuelling depot. The Stage 1 Proposal is located to the east of Moorebank Avenue and is an approximately rectangular parcel of land, about 400 m wide (east to west) and 850 m long (north to south). The Proposal also includes a rail link, approximately 3.5 km long, connecting the site to the Southern Sydney Freight Line (SSFL). The Stage 1 site and rail corridor footprint are presented in Figure 1.

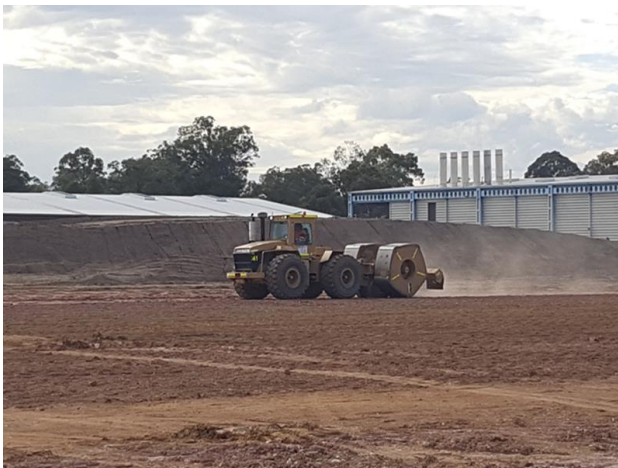
**Figure 3: Tractor and pentagonal drum used**

After the trial of varying number of passes using IRC it was found that 15 passes using a 3 m wide, 15 tonne, pentagonal dynamic compaction drum towed by a 4 wheeled tractor, as shown in Figure 3, was the best IRC treatment method for the subject site. This drum operates with a drop height of 150 mm to provide 22 kJ of energy during impact rolling. Dynamic response of the ground to the roller was monitored continuously via the Continuous Impact Response (CIR) system, which generated a “coloured map” identifying the level of soil response after the different number of passes. CIR

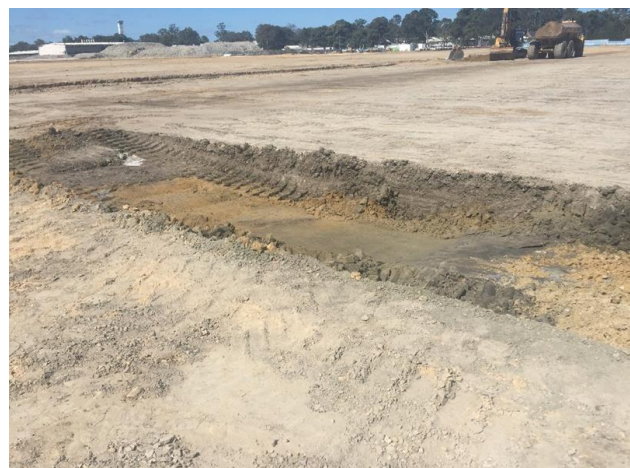
**Figure 4: Removal and replace of areas post proof rolling**

has been adopted by others to verify IRC treatment, as discussed by Kelly and Gil (2012), and further details relating to CIR technology are presented by Landpac (2017). Following the IRC treatment, the surface was smoothed using a smooth drum roller and a “post-IRC” proof roll was also carried out to identify potential areas of concern which were initially identified using the CIR system. Deflective areas which were observed during the post-IRC proof roll generally corresponded to areas which registered low or very low responses on the CIR plots (represented by yellow and red shading in Figures 5a) and 5b) which typically were related to former service trenches or low lying areas where there was a tendency for water to pond. These areas could not be improved by IRC and were remediated using conventional methods of removal and replacement of compacted fill as shown in Figure 4.
