## Case Analysis

# Marlin Coast Waste Water Treatment Plant Cairns, QLD

**DEEP IMPACT COMPACTION**

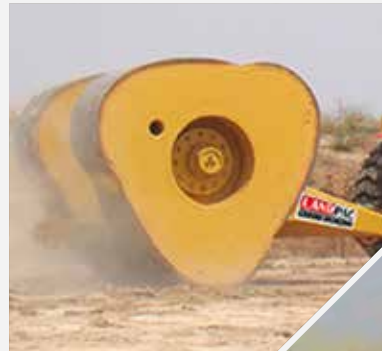
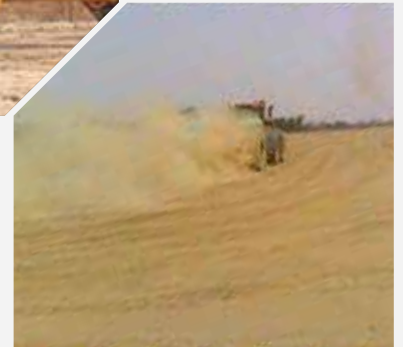
Impact Compaction using one of Landpac's 135kJ machines was used to compact the in-situ fill. Deep Impact Compaction was used to densify the sub-grade down to 5m (to achieve  $\geq 5\text{MPa}$  down to 5m) as it was not economically viable to remove and replace PASS and possible ASS materials with the water table up to 0.8m in places below the impacted working surface.
